# Memorial School Building Renovation & Reuse Project

Date: February 27, 2018

## Project Overview

The intent of the following report is to provide an initial review of the existing conditions for the Adams Memorial Middle School.

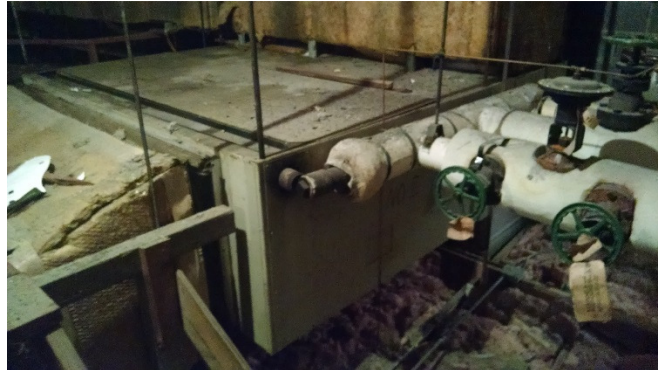
above the ceiling along the southwest wall. Existing air handling units all contain pneumatic control valves. Thermostats are located in the room. The heating systems are original to the building and condition is poor.

Figure 1 – Typical Air Handler Unit

Gymnasium heating and cooling system to consist of installing two (2) indirect natural gas fired roof top units with high efficiency direct expansion (DX) cooling coil. Ventilation for the space to be provided by the roof top units and incorporate differential enthalpy economizer.

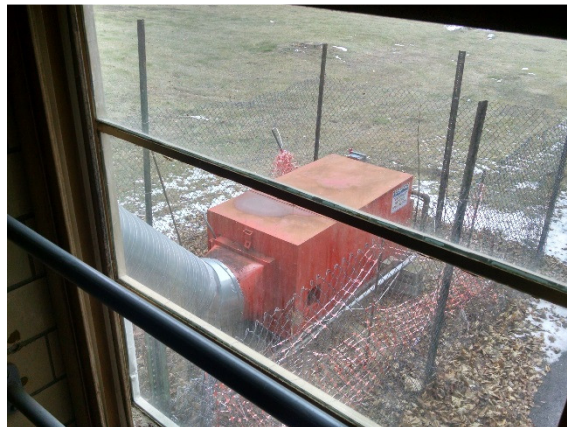
Temporary heat for the building is being provided by a natural gas fired, 100% outside direct fired make-up air unit. The unit is located in a fenced in area just outside of the building. A 24" diameter supply duct from the unit penetrates the building through the existing windows and dumps air in the main ground floor corridor. There are fans and blowers located throughout the building to help distribute the air.

Figure 2 – Temporary Make-Up Air Unit

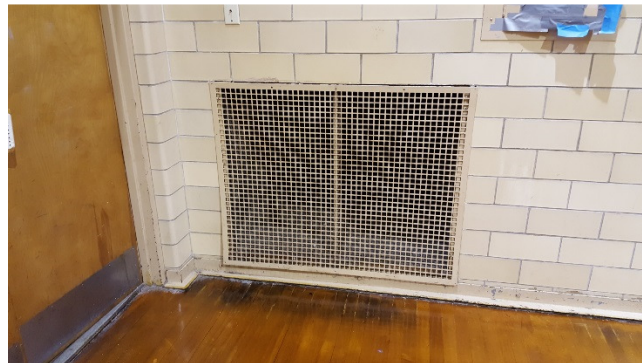
For the Gymnasium, ventilation air is provided by the air handler units located above the ceilings. Ventilation exhaust for the Gymnasium is provided by four (4) separate exhaust systems, one located at each corner of the gymnasium. Each system consists of a ductwork system that exhausts air from the gym using one (1) 36"x48" registers located just above the finished floor. Exhaust fans for these systems are down blast fans located on the roof.

Figure 3 – Typical Gymnasium Exhaust Register

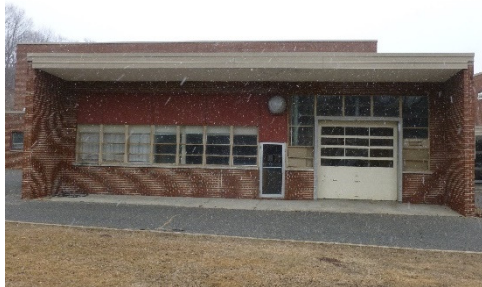
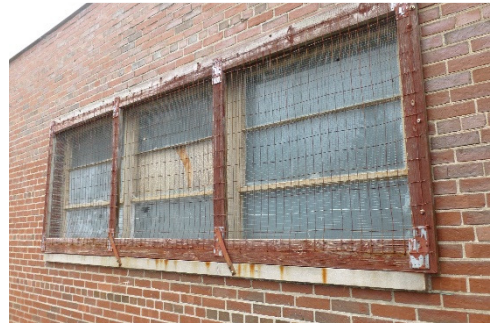
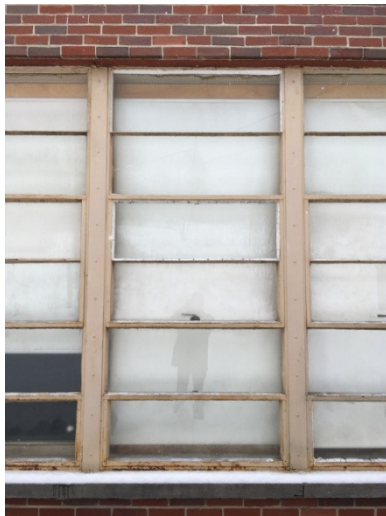
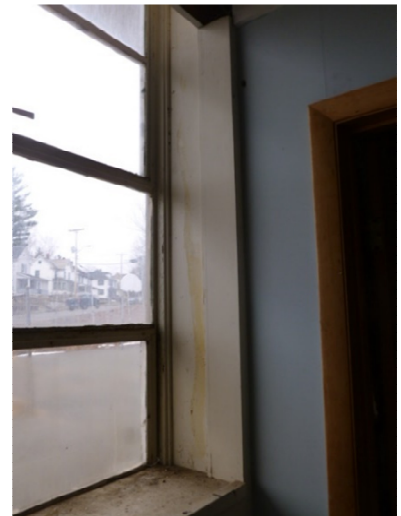
The original windows are non-thermally broken aluminum units with single pane glazing. They are in poor condition and offer no thermal separation from the outdoors. Many panes in the work area are cracked, and have been secured from the outside with chicken-wire screens. In the existing shop areas, the upper windows have been boarded over with painted plywood.

Wood trim surrounds the window shades, which would have to be removed should the windows be replaced. Existing interior trim is in poor condition and will need to be removed to allow for future window replacement.

Existing aluminum windows to be replaced with new fiberglass windows of similar operation with a fixed unit above and an operable awning unit below. The windows will meet the current energy code requirements for U-value and shading coefficient. Replace damaged exterior doors and replace interior door to create required fire separation.

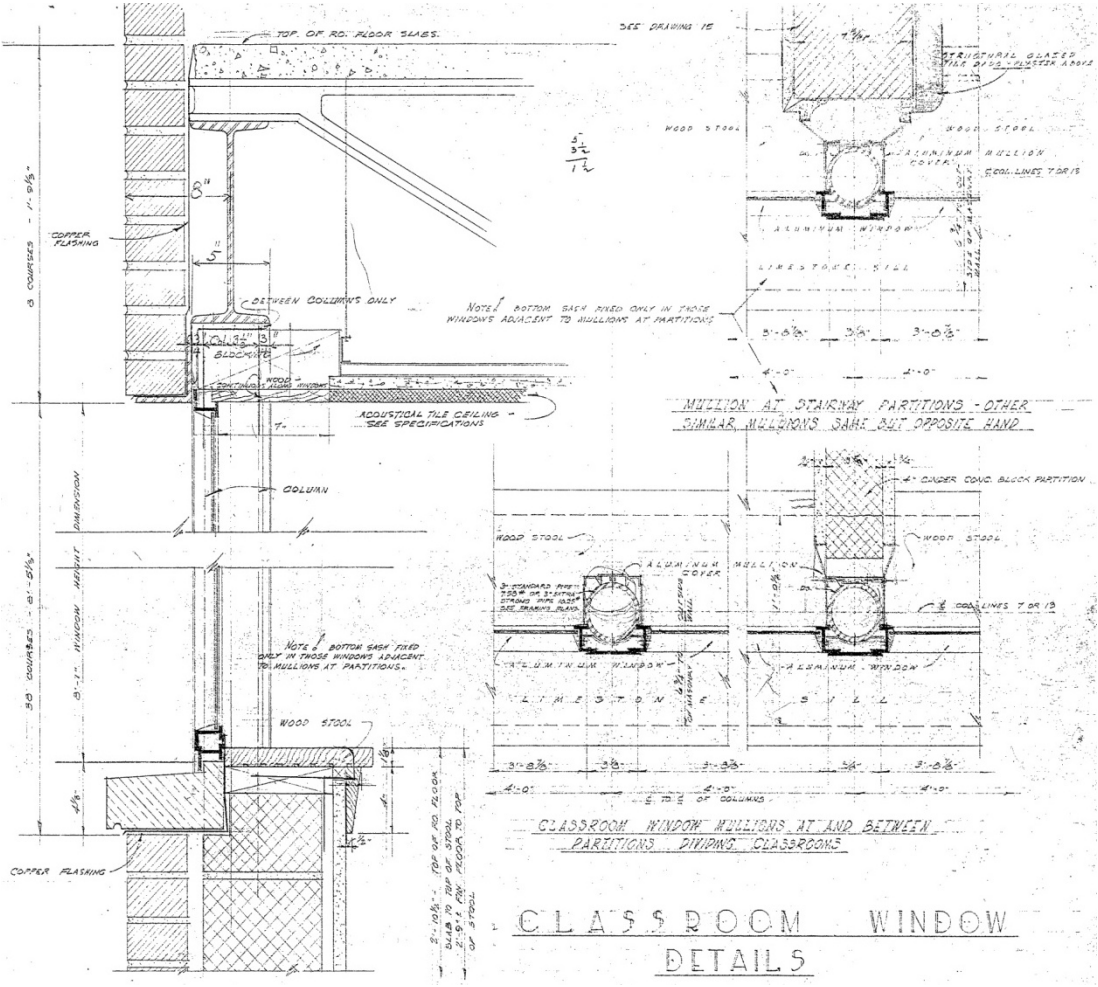
There is a pipe column located between each window, supporting the continuous lintel above. The windows have stone sills, which are heavily stained, but are otherwise in passable condition.

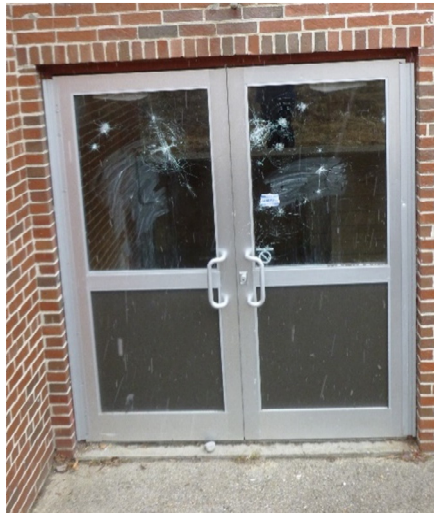
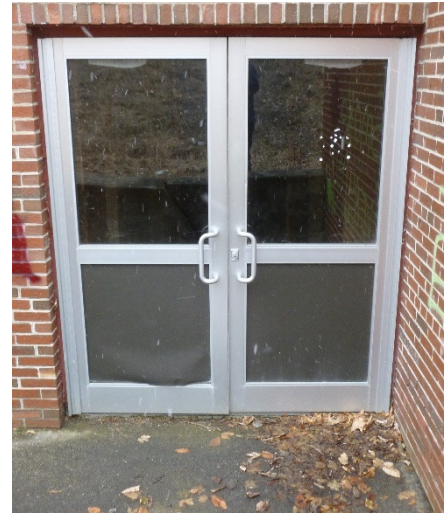
The original exterior doors appear to be thermally broken aluminum entrance doors with full glass lites. Most are in acceptable condition. The two doors out the southwest, to either side of the gym are half glass with spandrel panel below. These two doors have cracked/broken glass and bent panels.
